TOLERANCE .XX ± .007 .XXX ± .003	CONTRACT SSP-4	REVISION 10/1/2001 1/30/2002 4/30/2002	SCALE: ND: 17-04001
MATERIAL	PREAMP CIRCUIT		
FINISH	OPTEC, Inc.

# FINAL INSPECTION SHEET

Type No. **G5852-203**  
Quantity **3 pcs.**  
Note

Ref: RA 6198, our P.O. 8155

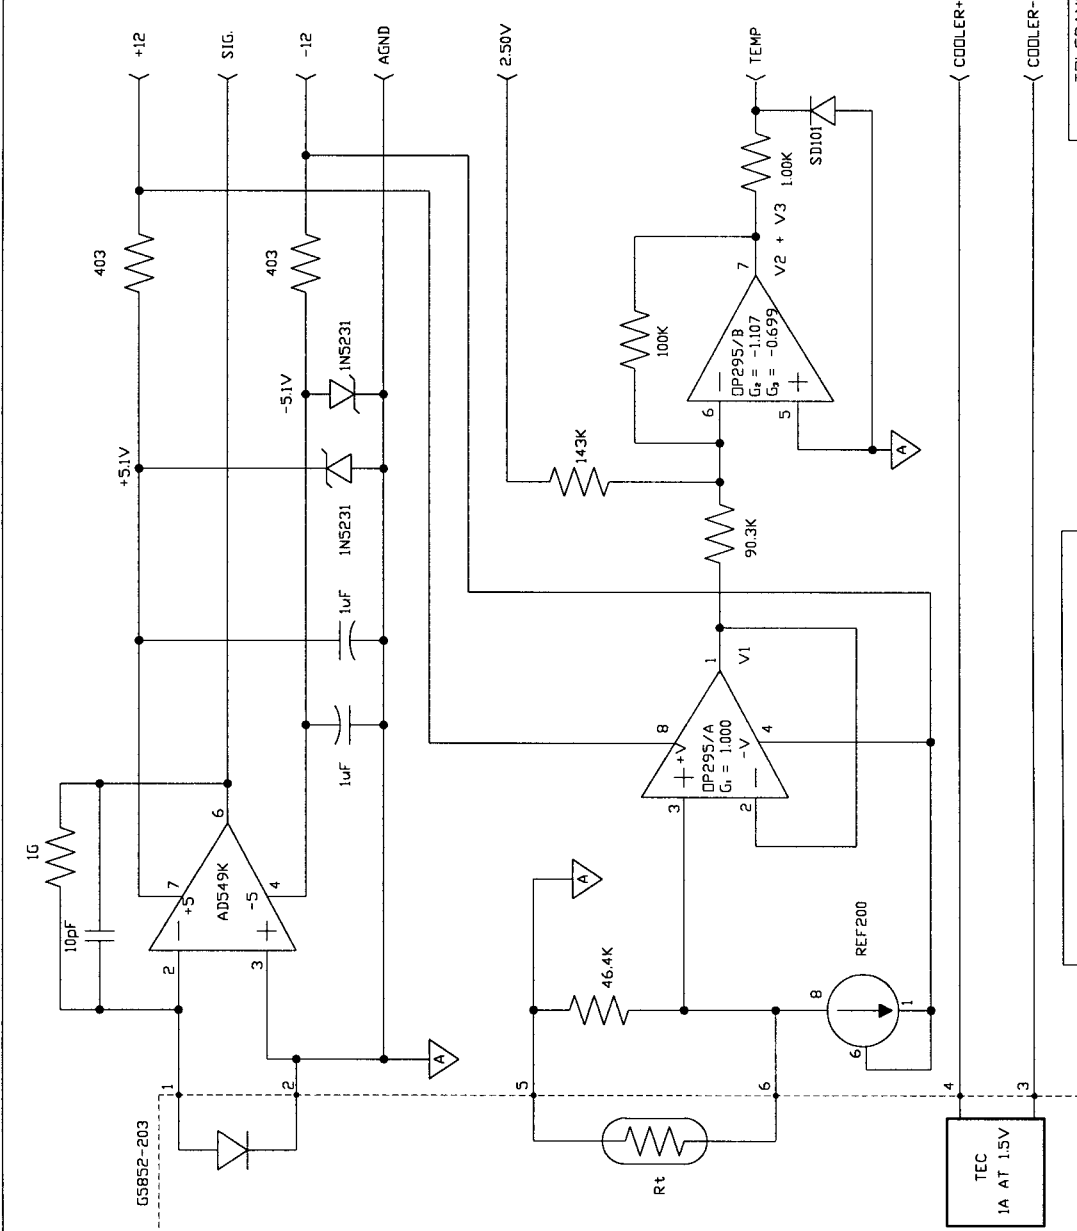
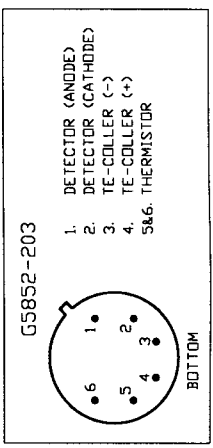
I ordered and received late last year a G5852-203 for our evaluation and prototype construction of a photometer used in astronomy. That detector worked fine with our preamp circuit shown in drawing #17-04001. The initial offset voltage from the AD8551 with the detector attached was within expected limits of +/- 20 mv. The actual value was 8 mv. When the cooler was tuned on, the offset voltage would fall to a value closer to zero as expected. The offset voltage was stable and repeatable through many on/off cycles. The operating temperature can be set with our equipment to a value within the range of 0 to -40 degrees C. Normal operating temperature is set at -35 degrees C. Current through the TEC is limited to a maximum of 0.9 amps. The voltage applied to the TEC is very stable with noise in the mv range. The prototype instrument with the first G5852-203 has worked fine for the last 3 months and is still operating within expected limits.

The four pieces in question were installed in identically equipment as compared to the prototype unit. At room temperature (TEC off), the units exhibit an offset voltage which is near the expected limits but higher compared to the prototype unit. When the TEC is turned on, the offset voltage would increase to a value of -75 to -300 mv depending on the unit. This change in offset would take about 4 seconds which is close to the cooling time with a set temperature of -25 degrees C. Under close examination, there would be an overshoot of about 10% of the value before the unit would settle down to its stable offset voltage. When the TEC is turned off, the offset voltage would slowly settle down to its room temperature value over a period of 1 to 2 minutes. As with the turn on of the TEC, there is a slight rise in the offset voltage when the TEC is just turned off before it begins to fall. This test is repeatable at all times with the detectors even when the cooler is powered by a separate power supply. However, room temperature offset voltage and the cooled offset voltage would be a little different each time the test was done.

It appears to me that condensation inside the detector package might be causing a surface leakage situation. The fast change in the offset voltage when the TEC is turned on and the slow change back to the original offset voltage when the TEC is turn off looks to me like water condensing and then drying.
