# Pyxis 2” Firmware Upgrade

## *Instructions for Updating your Pyxis 2” Firmware.*

## #17572 – Pyxis 2” Firmware Upgrade

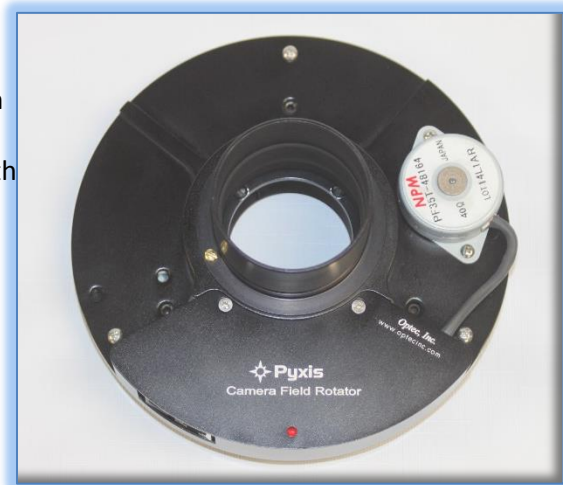
### Step 1

Make sure Pyxis 2” is turned OFF and all cabling is disconnected. It is also best to perform the update with the Pyxis removed from your imaging train. Orient it telescope side up and locate the circuit board cover with the red LED visible.

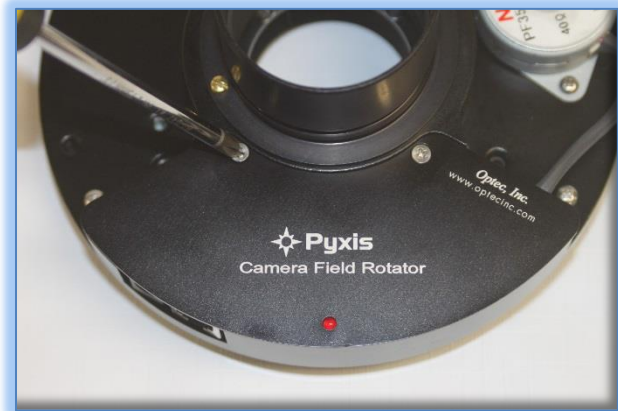
### Step 2

Unscrew the two Philips head screws and remove the cover plate. Be sure not to lose these screws and put them in a safe place.

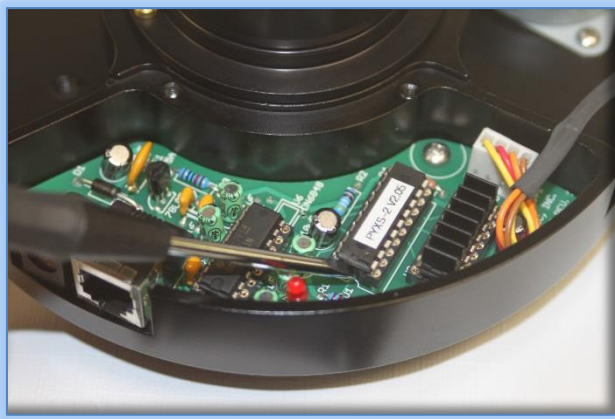
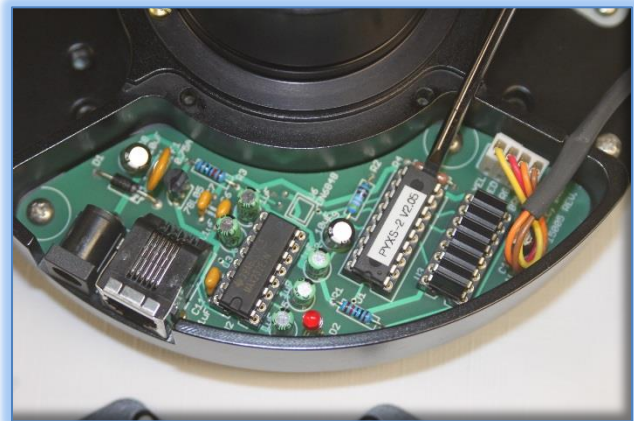
### Step 3

The PIC chip to be replaced is the longer 18-pin DIP (dual in-line package) labeled with the old firmware. Using a flat head screwdriver carefully pry one end of the PIC, then the other to remove it from the socket. Use caution when removing the chip, being careful not to damage the socket.

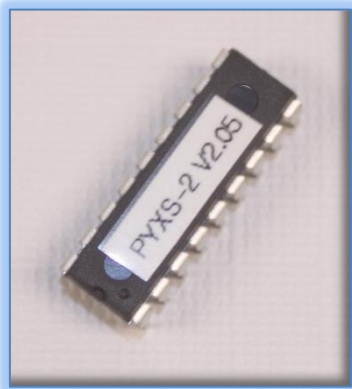
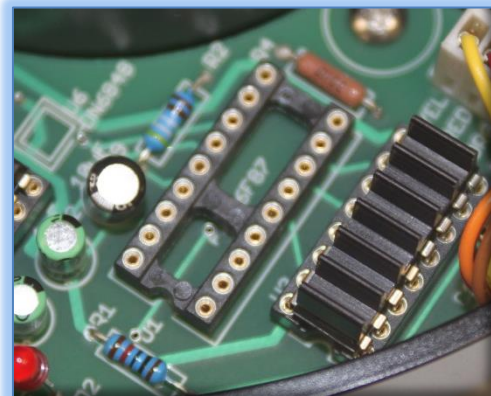
### Step 4

Take the replacement PIC chip with the new firmware and notice the curved notch in the picture below. This notch designated is Pin 1 on the DIP package. Also note the curved cut out section on the socket, this notch identifies pin 1 on the socket.

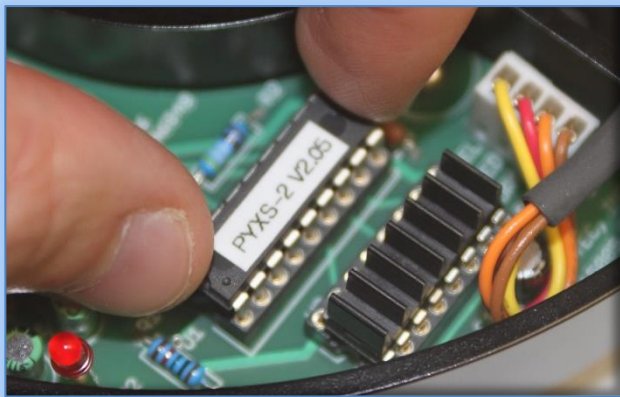
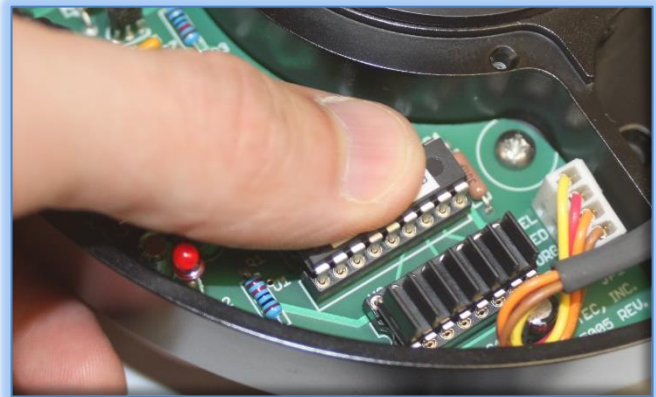
### Step 5

Align both curved cut out sections, both with the chip and the socket. Making sure the pins are aligned with the socket holes (this may require the pins being bent inward slightly), push the chip into place until the pins are properly seated.

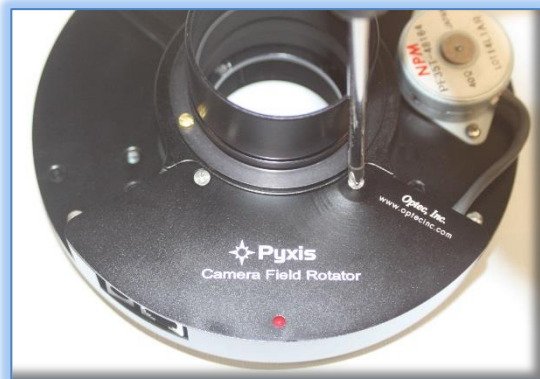
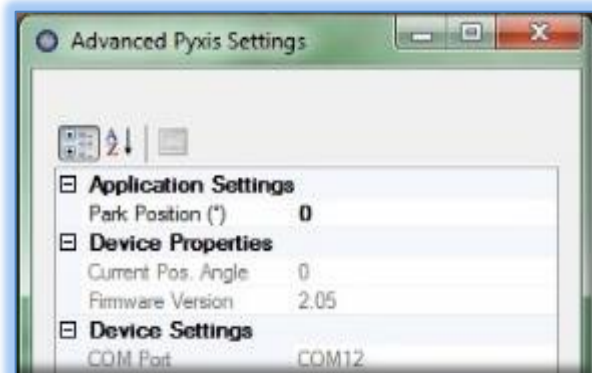
### Step 6

Re-install the circuit board cover being certain the LED lines up properly with the hole in the cover. You may then connect the cabling, power it up, and connect to the Optec Pyxis Rotator Control program. In the Setup tab under Advanced Settings will be displayed the new firmware version.
